Debris/Ice/TPS Assessment and Integrated Photographic Analysis of Shuttle mission STS-112

**DEBRIS/ICE/TPS ASSESSMENT and
INTEGRATED PHOTOGRAPHIC ANALYSIS
OF SHUTTLE MISSION STS-112**

Armando Oliu
Process Engineering/Mechanical System Division/ET-SRB Branch,
Kennedy Space Center, Florida

October 7, 2002

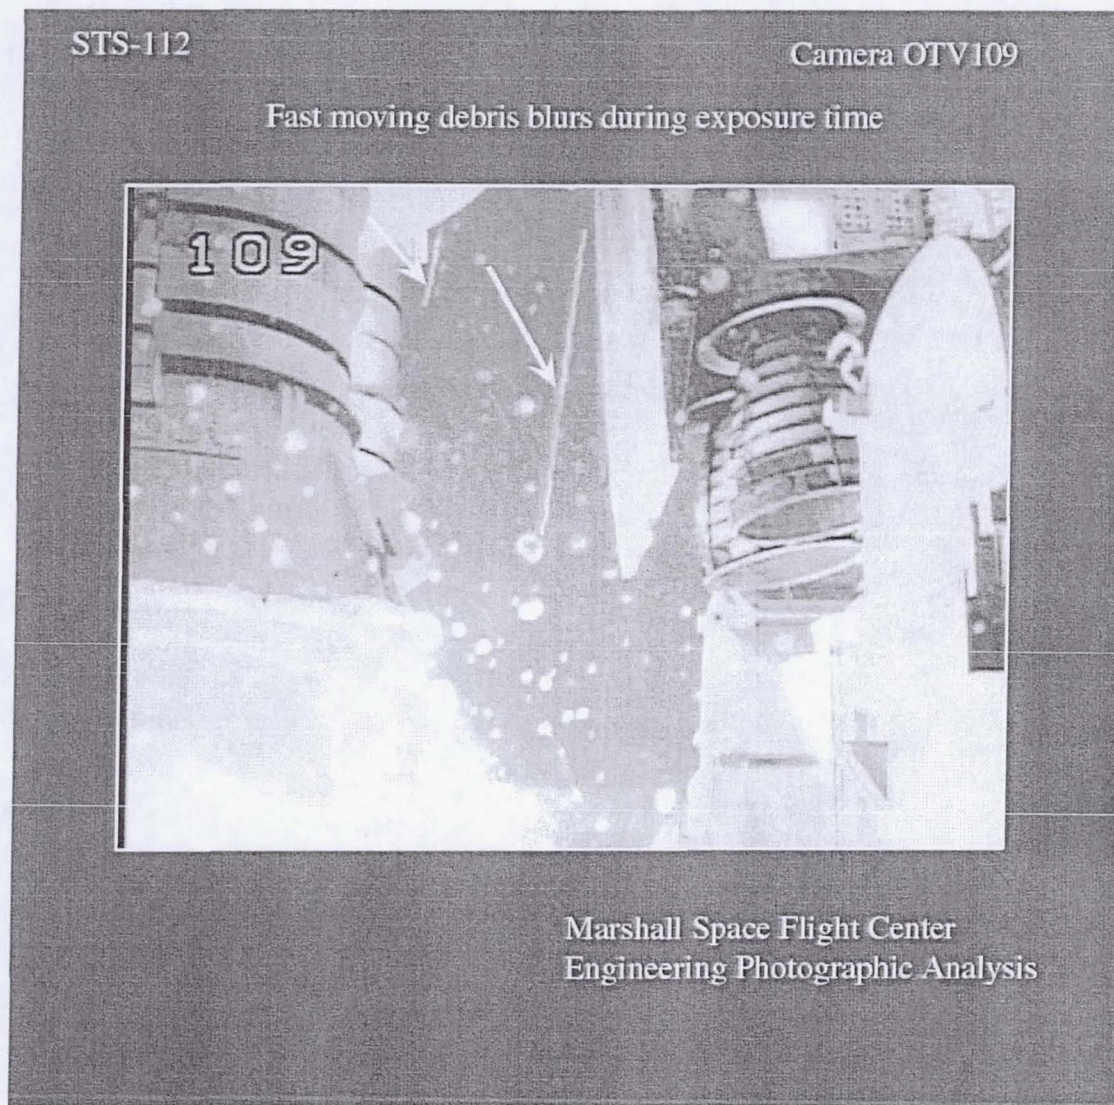
Figure 17. OTV109: Debris Falling Aft of Vehicle at Liftoff

OTV109: Debris Falling Aft of Vehicle at Liftoff

A fast moving debris particle was imaged as it fell aft of the vehicle. This is a common observation.

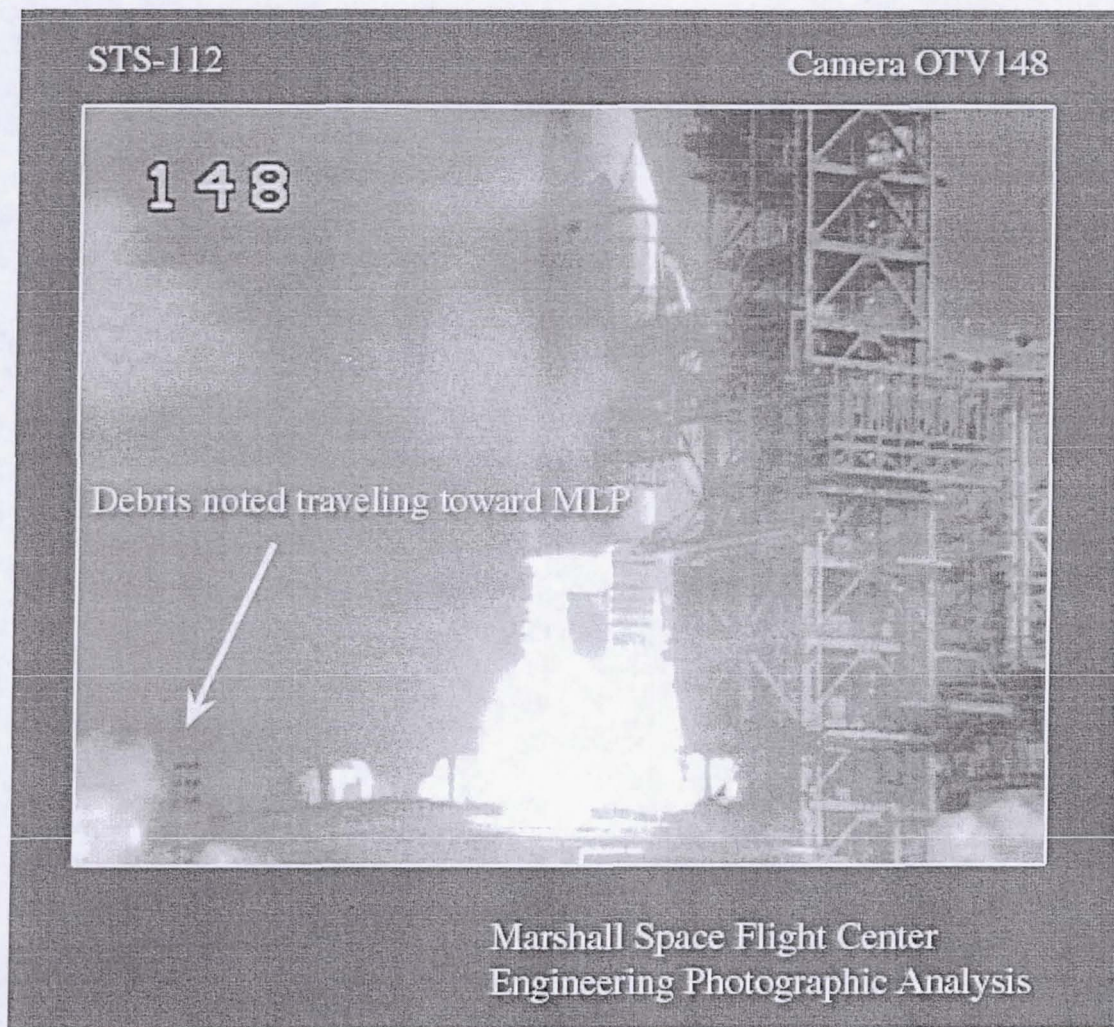
Figure 21. OTV148: Debris Noted Traveling Towards MLP

OTV148: Debris Noted Traveling Towards MLP

Debris was noted traveling towards MLP just after liftoff.

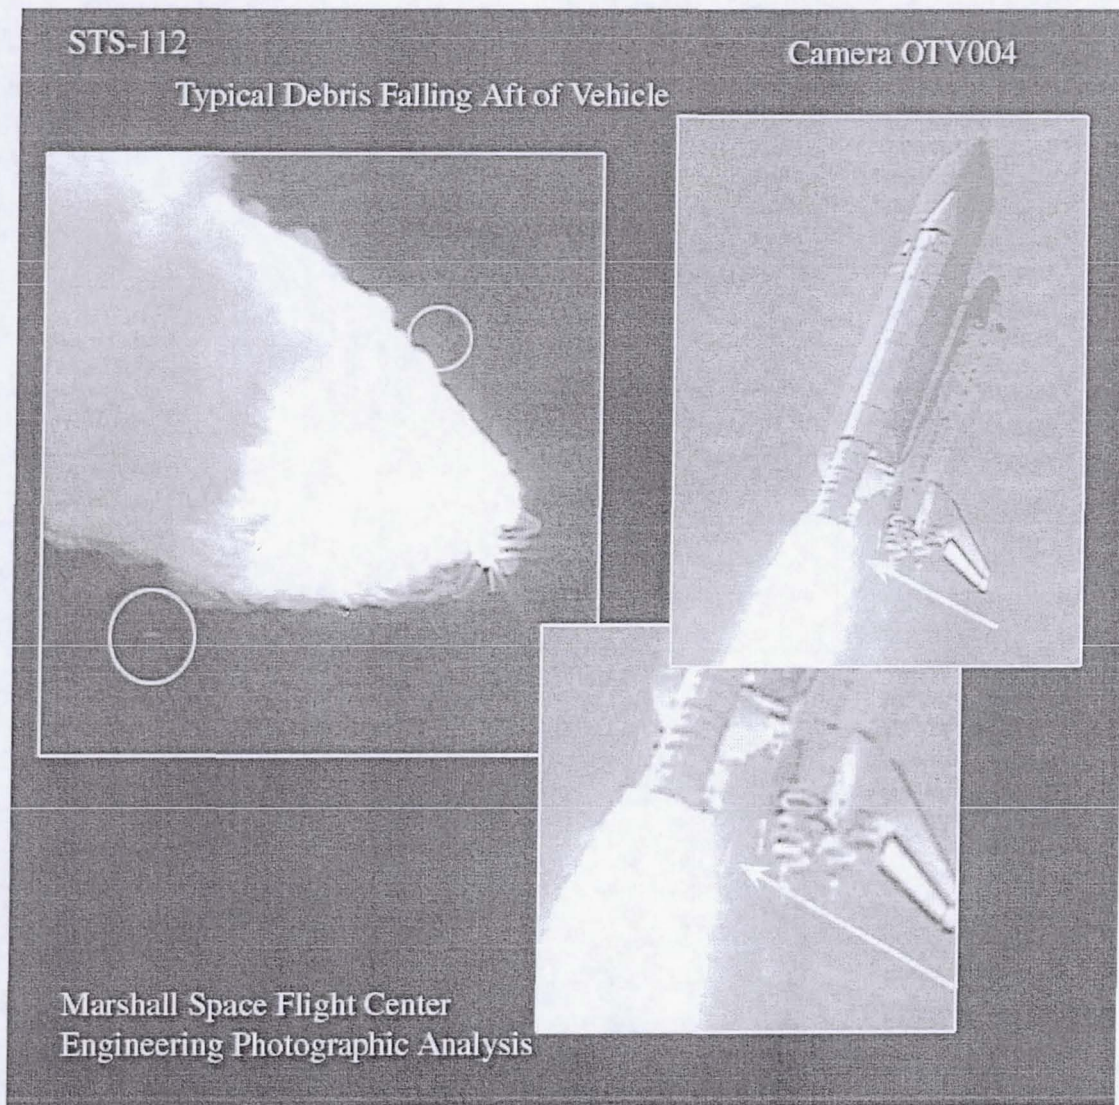
Figure 22. TV004B: Debris Falling Aft

TV004B: Debris Falling Aft

Typical debris falling aft of the vehicle was imaged. At this time during ascent, Instafoam is the likely source for the debris ejected from the SRB plumes.

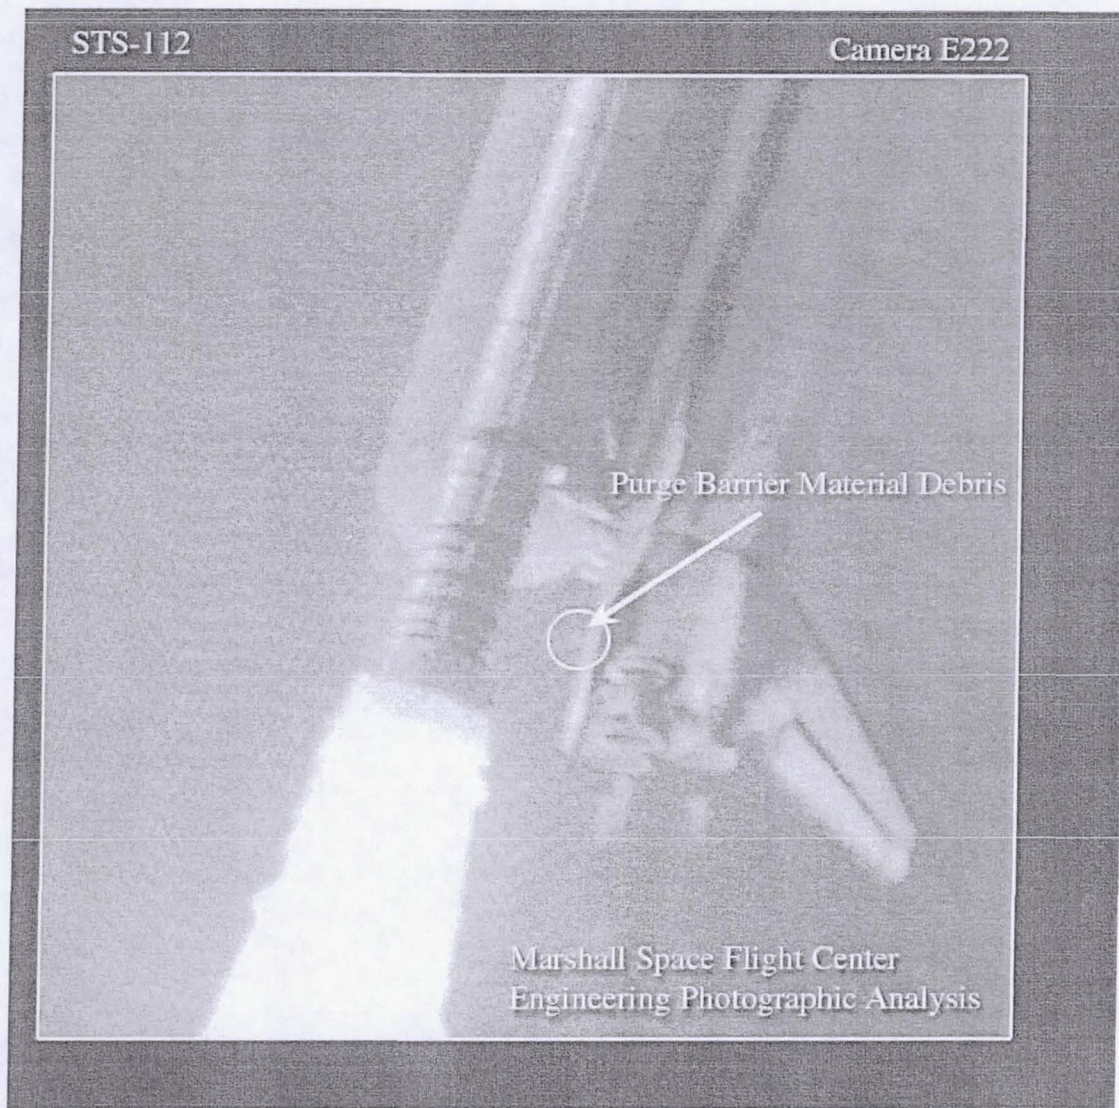
Figure 23. E222: Purge Barrier Material Debris Falling Aft

E222: Purge Barrier Material Debris Falling Aft

Umbilical Well Purge Barrier material is a frequent source of debris.

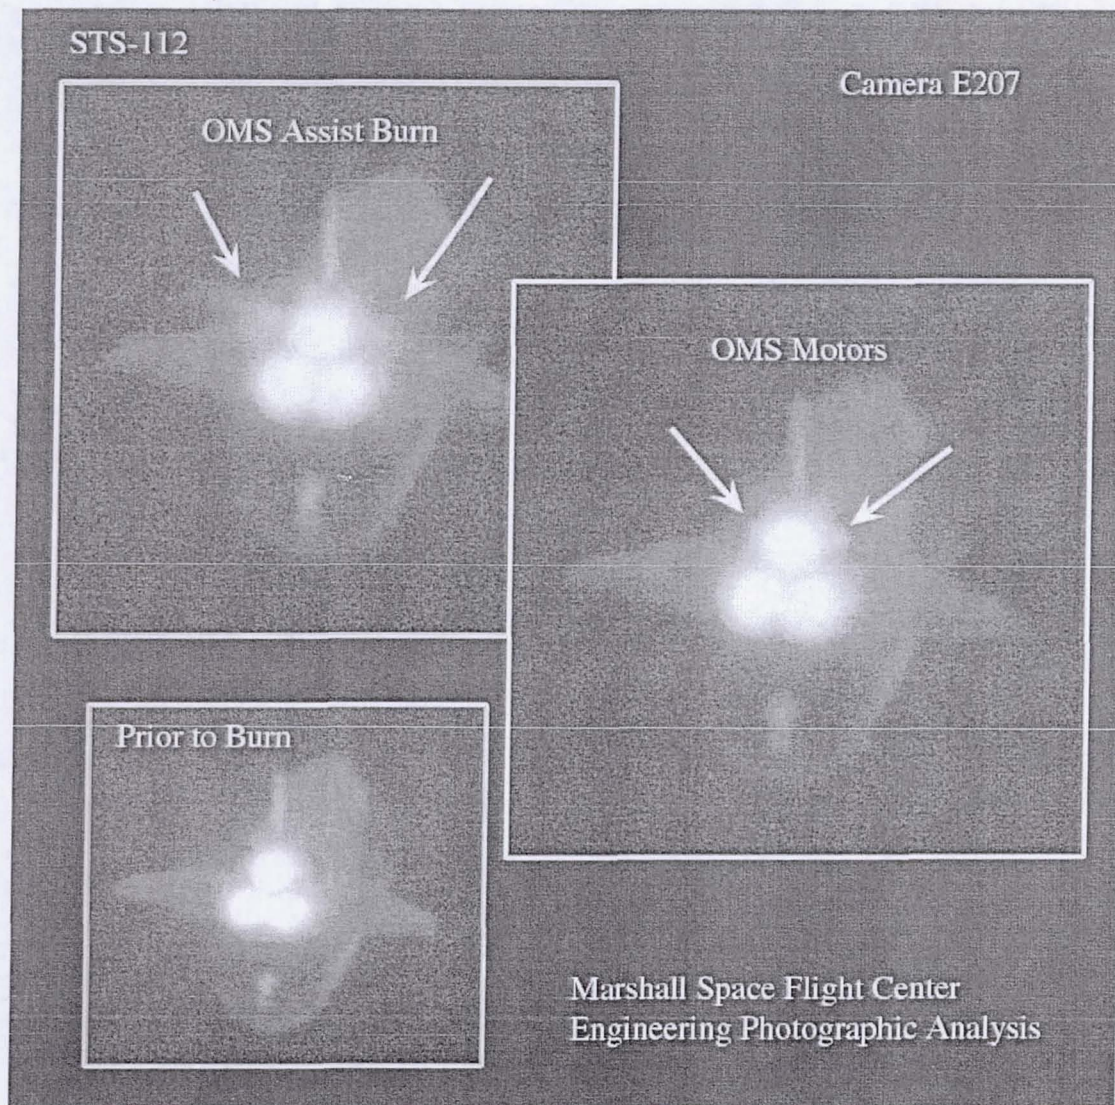
Figure 24. E207: OMS Burn after SRB Separation

E207: OMS Burn after SRB Separation

The slightly orange colored streak noted near the SSME exhaust is indicative of the OMS Assist burn. This OMS Assist burn was imaged at 280:19:48:03.213 UTC, approximately 10 seconds after SRB separation. Due to the clarity of the viewing conditions, the OMS burn was seen to persist for some time, note the arrows pointing to the small glow emanating from the OMS motors.

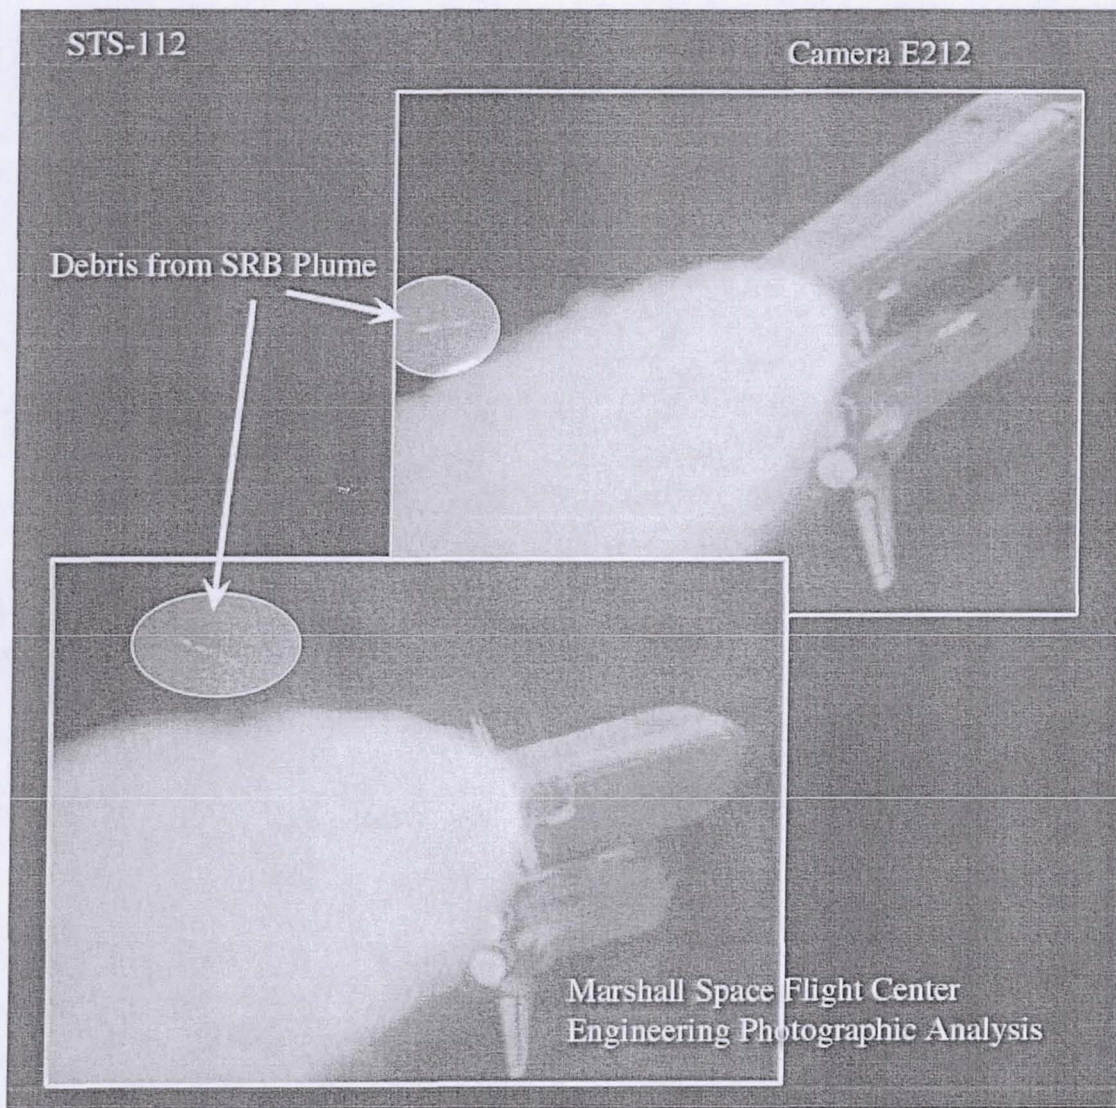
Figure 25. E212: Debris Ejected from SRB Plumes

E212: Debris Ejected from SRB Plumes

Debris was ejected from the SRB plumes during ascent. Also imaged at this time were Linear Optical Distortions.

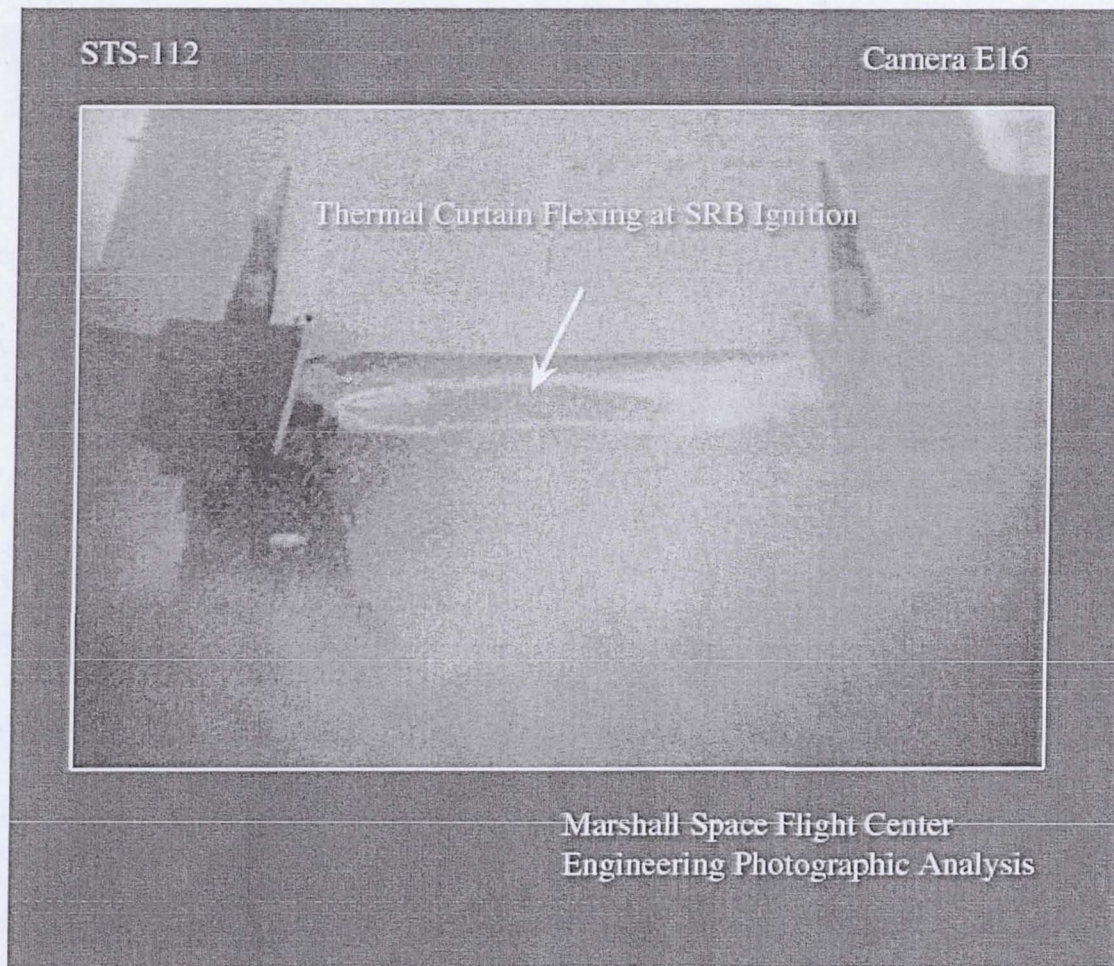
Figure 29. E016: Thermal Curtain Flexing at Left SRB Ignition

E016: Thermal Curtain Flexing at Left SRB Ignition

Image of the Thermal Curtain flexing at Left SRB ignition.

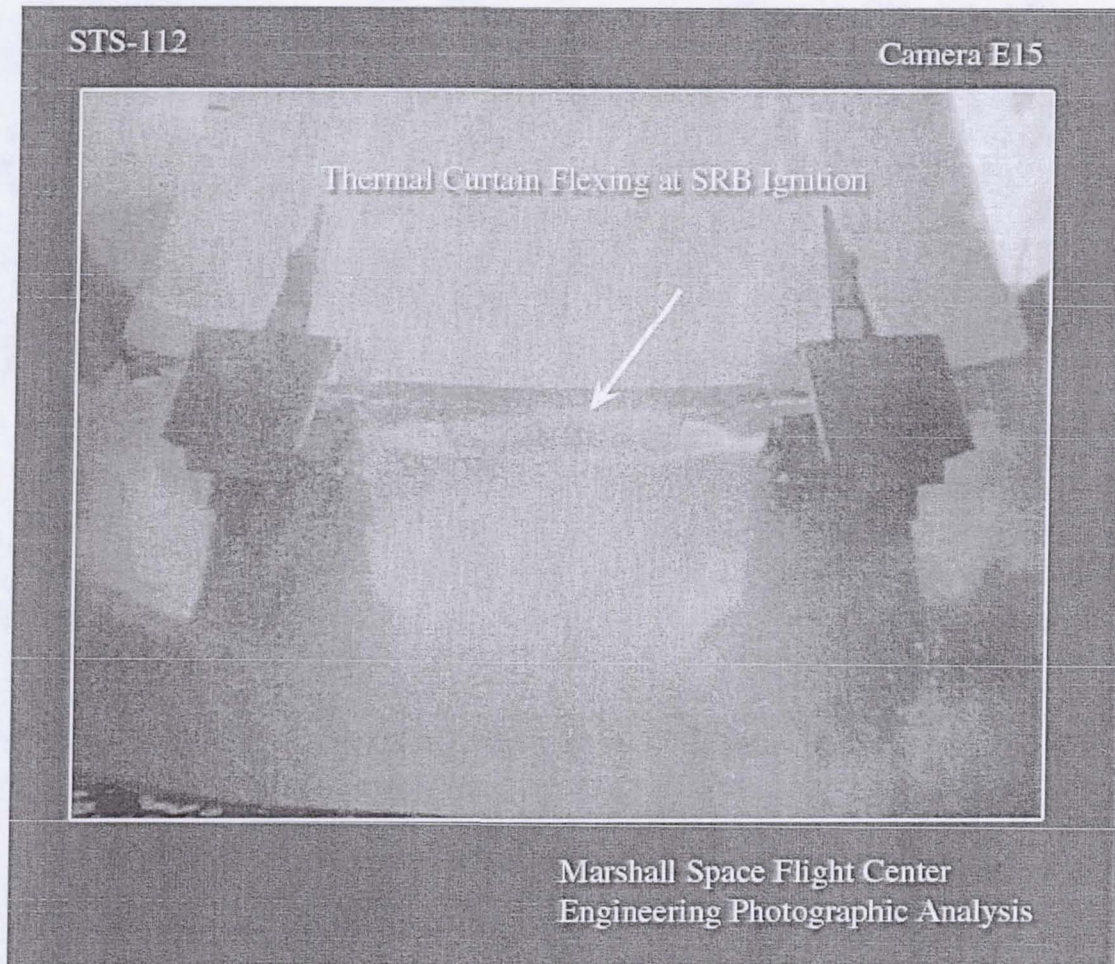
Figure 30. E015: Thermal Curtain Flexing at Right SRB Ignition

E015: Thermal Curtain Flexing at Right SRB Ignition

Image of the Thermal Curtain flexing at Right SRB ignition.

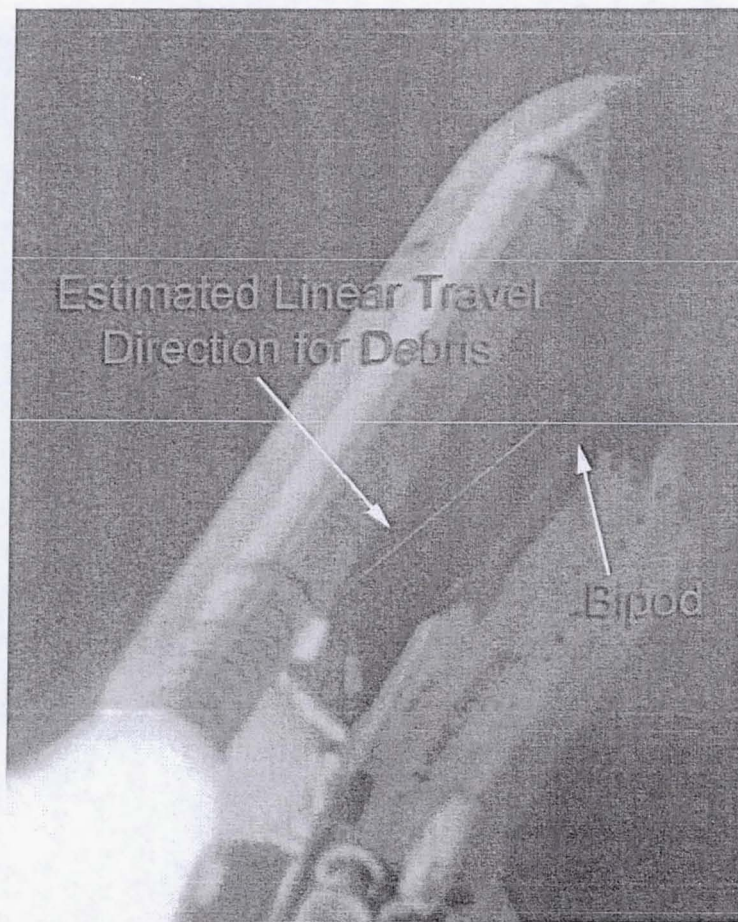
Figure 33. Linear Debris Trajectory Estimate

The debris impact on the left SRB observed Near IEA Box occurred at approximately 280:19:46:24.6 UTC. A sequence of images tracking debris prior to impact indicate the general direction of travel of the debris. A linear curve fit to the pixel coordinates of the debris at frames where the debris was visible yields the linear debris trajectory estimate shown. This linear extrapolation places the debris in the vicinity of the Bipod foot/ramp during its trajectory.

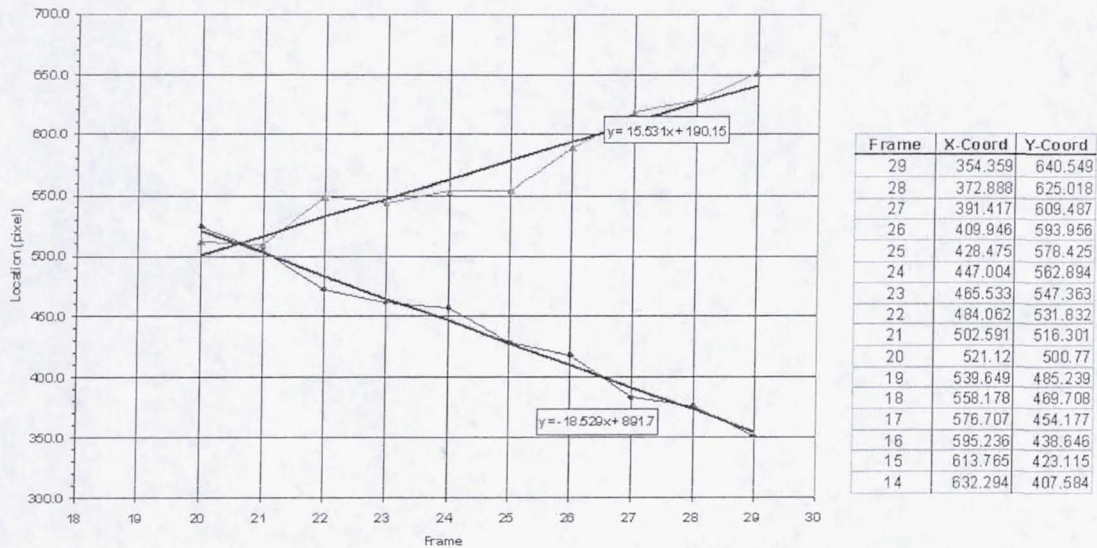
Figure 34. Debris Position Curve Fit

Y-coordinate curve fit $y = 15.531 \cdot \text{frame} + 190.15$

Frame values prior to "frame 16" place the debris forward of the Bipod.

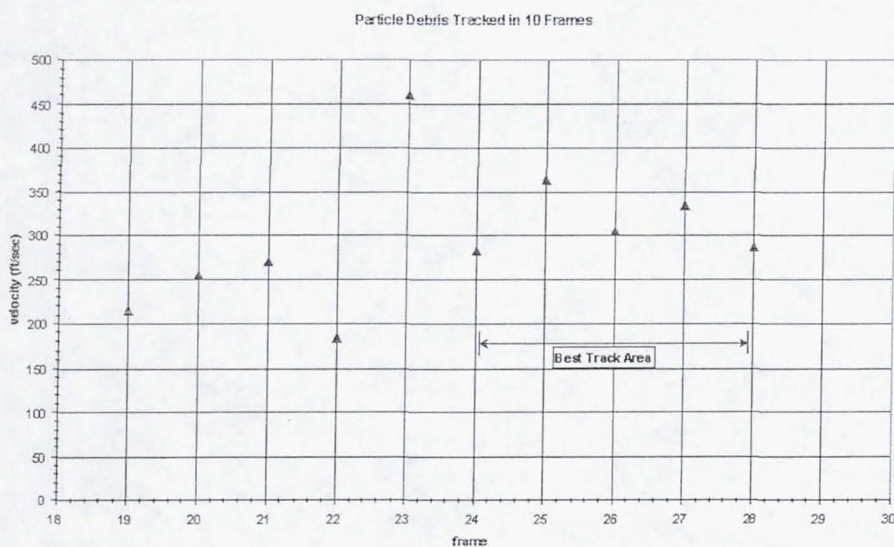
Figure 35. Debris Velocity Determination

Average velocity over frames tracking debris particle is 295 ft/sec

frame	x	y	distance traveled (px)	distance traveled (ft)	speed (ft/sec)
19	534	441	20.51828453	2.154419876	215.4419876
20	519	455	24.18677324	2.539611191	253.9611191
21	498	467	25.8068758	2.709732459	270.9732459
22	483	488	17.4642492	1.833746166	183.3746166
23	466	492	43.8634244	4.605659562	460.5659562
24	436	524	26.90724809	2.82526105	282.526105
25	418	544	34.6554469	3.638821925	363.8821925
26	394	568	29.06888371	3.052232789	305.2232789
27	375	591	31.82766093	3.341904397	334.1904397
28	353	614	27.29468813	2.865942253	286.5942253
29	340	638			
					295.6733167

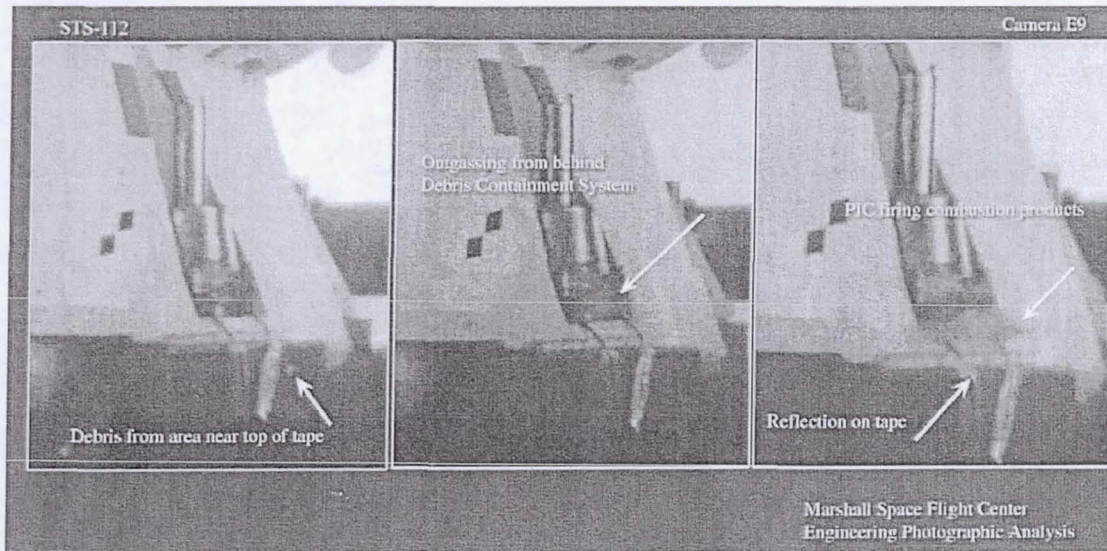
Figure 36. E009: Debris and Combustion Products HDP M1

Debris was observed, originating from area near top of tape on right pyrotechnic cable and falling past HDP shoe. The debris was imaged at 280:19:45:46.829 UTC.

Outgassing was observed from the alcove of the debris containment system. This was imaged at 280:19:45:47.391 UTC.

A reflection was observed from the tape on the left pyrotechnic wire. This was imaged at 280:19:45:51.031 UTC. PIC firing combustion products are also visible in the image.

E009	Pyrotechnic wires appear in nominal configuration. Debris observed, originating from area near top of tape on right pyrotechnic wire, falling past HDP shoe, imaged at 280:19:45:46.829 UTC. Outgassing observed from alcove of debris containment system, imaged at 280:19:45:47.391 UTC. Reflection observed from tape on left pyrotechnic wire, imaged at 280:19:45:51.031 UTC. SRB holddown post M-1 PIC firing time noted at 280:19:45:51.026 UTC.
E010	Stud hang-up observed on Holddown Post M-3, imaged at 280:19:45:51.611 UTC. Typical lift-off debris from SRB. SRB holddown post M-3 PIC firing time noted at 280:19:45:51.028 UTC.
E011	Foam debris emanating from SRB blast hole. Typical pad debris.
E012	Pyrotechnic wires appear in nominal configuration. Typical pad debris. Left pyrotechnic wire stretched several feet before detaching from SRB. SRB holddown post M-5 PIC firing time noted at 280:19:45:51.026 UTC.

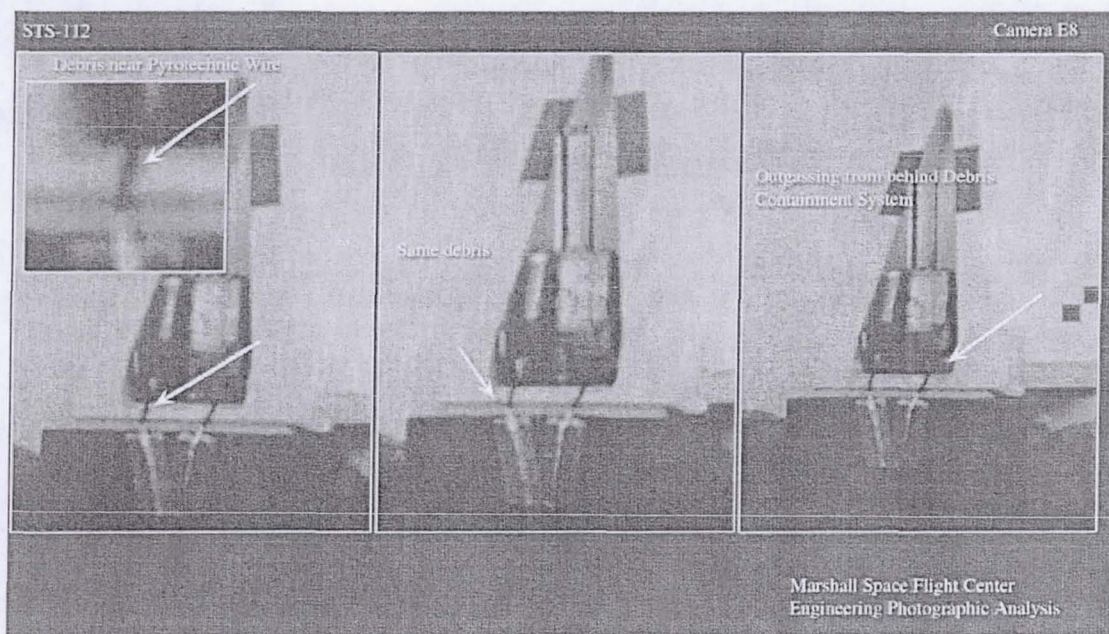
Figure 37. E008: Debris and Outgassing HDP M2

E008: Debris and Outgassing HDP M2

Debris, originating from under the left pyrotechnic cable at Holddown Post M2, was observed falling from the Debris Containment System. The first image was timed at 280:19:45:46.447 UTC and the second, as the debris fell, was timed at 280:19:45:46.507 UTC.

Outgassing from the right side of the Debris Containment System Alcove, first noted at 280:19:45:47.322 UTC, was also observed. The image illustrating the outgassing was timed at 280:19:45:47.398 UTC.

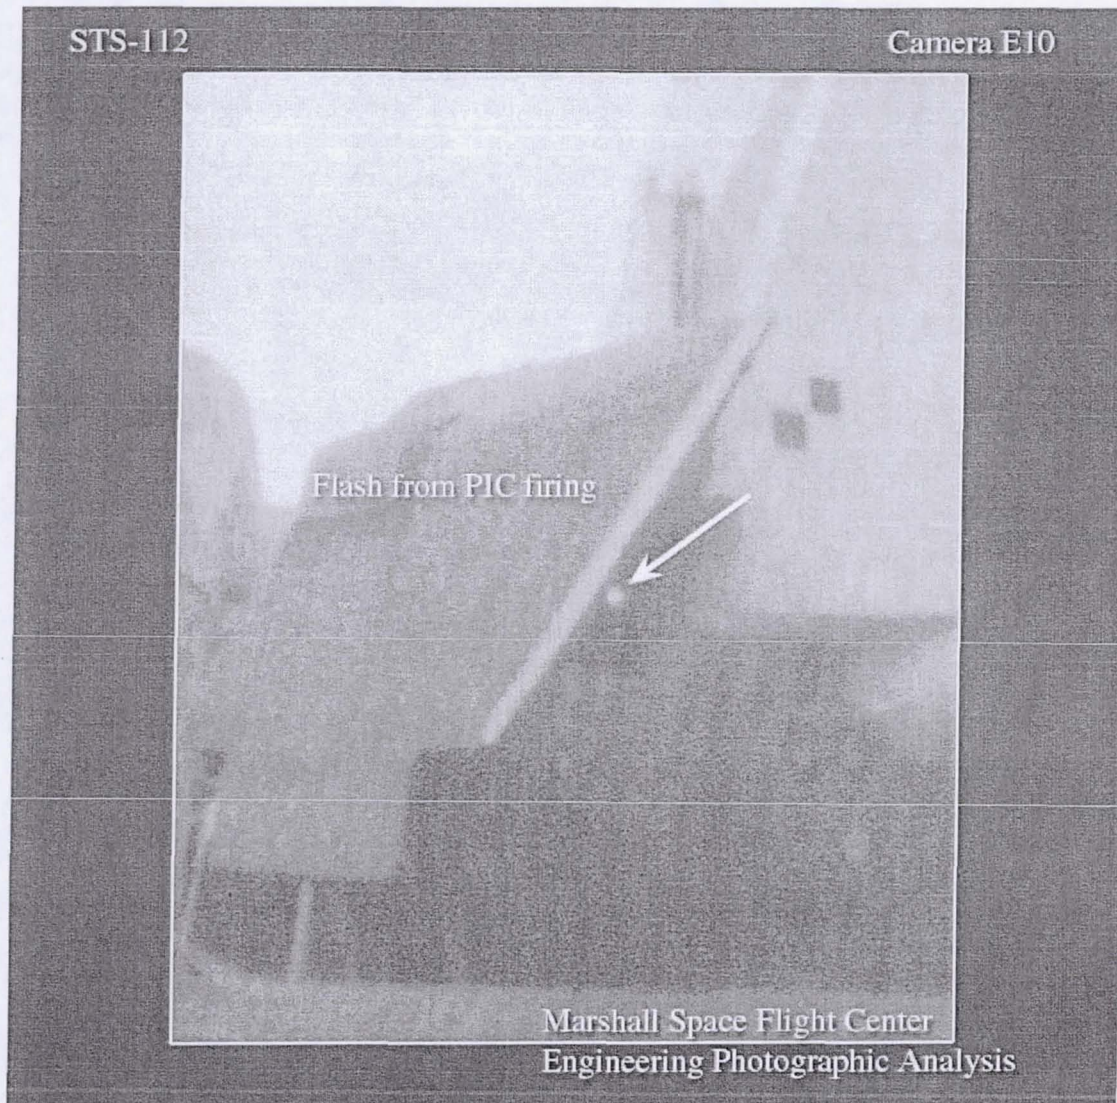
Figure 38. E010: Flash from PIC Firing HDP M3

E010: Flash from PIC Firing HDP M3

Usually, the combustion products from PIC firing are obscured by the Holddown Post covers. However, occasionally PIC firing combustion products can be observed. SRB holddown post M3 PIC firing time noted at 280:19:45.51.028 UTC.

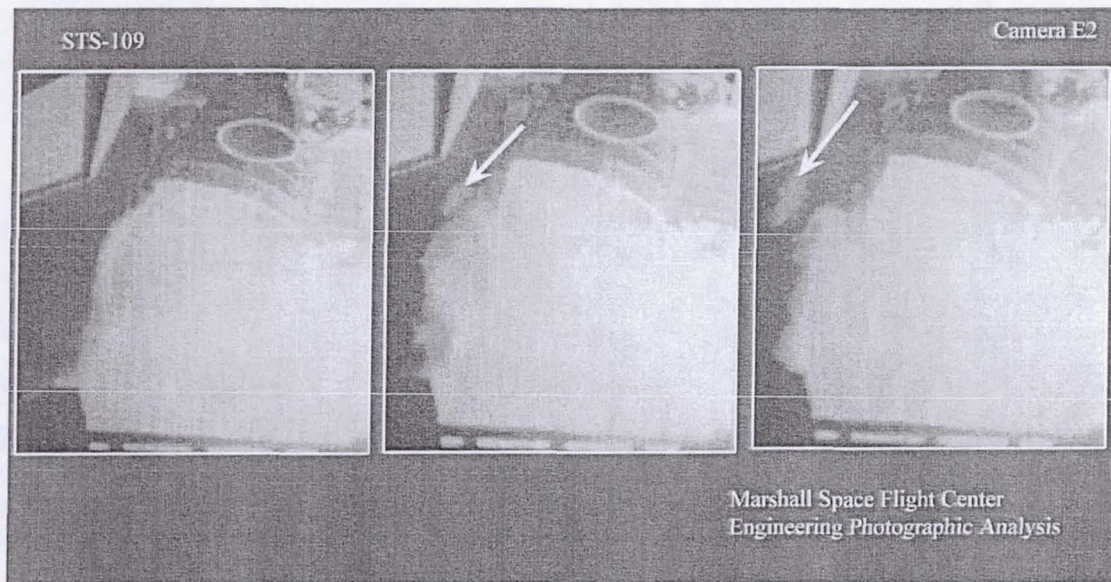
Figure 39. E002: STS-108 and STS-109 Plume Review

E002: STS-108 and STS-109 Plume Review

In reviewing missions STS-108 and STS-109 plume bulges were also observed. These SSME #1 plume bulges were of lesser magnitude and appeared to be further from the nozzle than those noted on STS-111, STS-110, or STS-112. Also noted and imaged on STS-109, at the time of the plume bulge, is an acoustic shock moving away from the plume. The three images in the sequence were timed at 060:11:21:58.479, 060:11:21:58.482, and 060:11:21:58.484 UTC, or approximately 2.8 seconds from STS-109 SSME#1 start time (060:11:21:55.703 UTC).

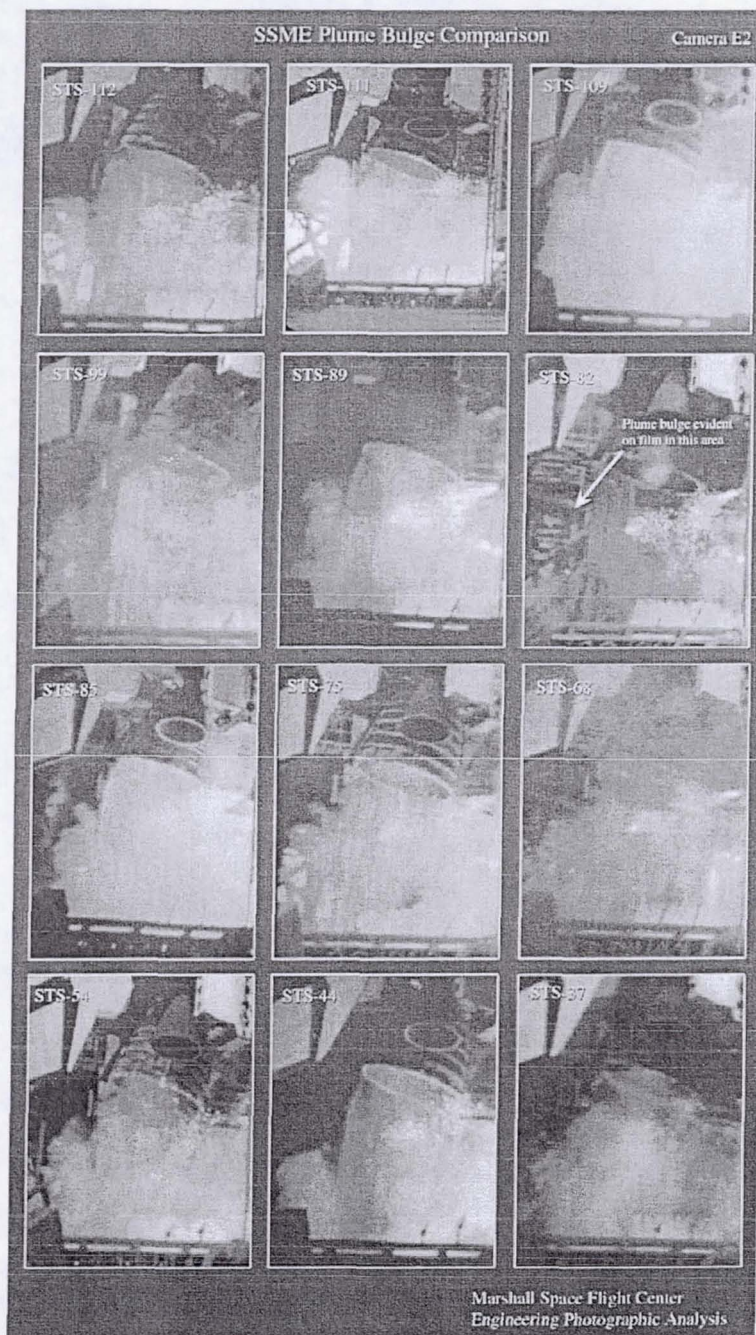
Figure 40. E002: Plume Bulge Comparison Imagery

E002: Plume Bulge Comparison Imagery

Each film was analyzed during the time between SSME#1 ignition and Mach diamond formation for plume fluctuations similar to the type noted in STS-111. Plume boundary fluctuations were evident in each film. The largest fluctuation observed was placed in the image for comparison.
